VULNERABILITY OF SPACE STATION FREEDOM MODULES-
A Study of the Effects of Module Perforation on Crew &
Equipment

Volume I - Experimental Program

By : J. Serrano, D. Gala, D.J. Liquornik & R. A. Hayami
University of Alabama in Huntsville
and
Joel Williamsen,
Structural Development Branch
NASA, Marshall Space Flight Center
Huntsville AL

Final Report, Vol. I: Contract NCC8-28
Period 09 September 1993 - 14 March 1995

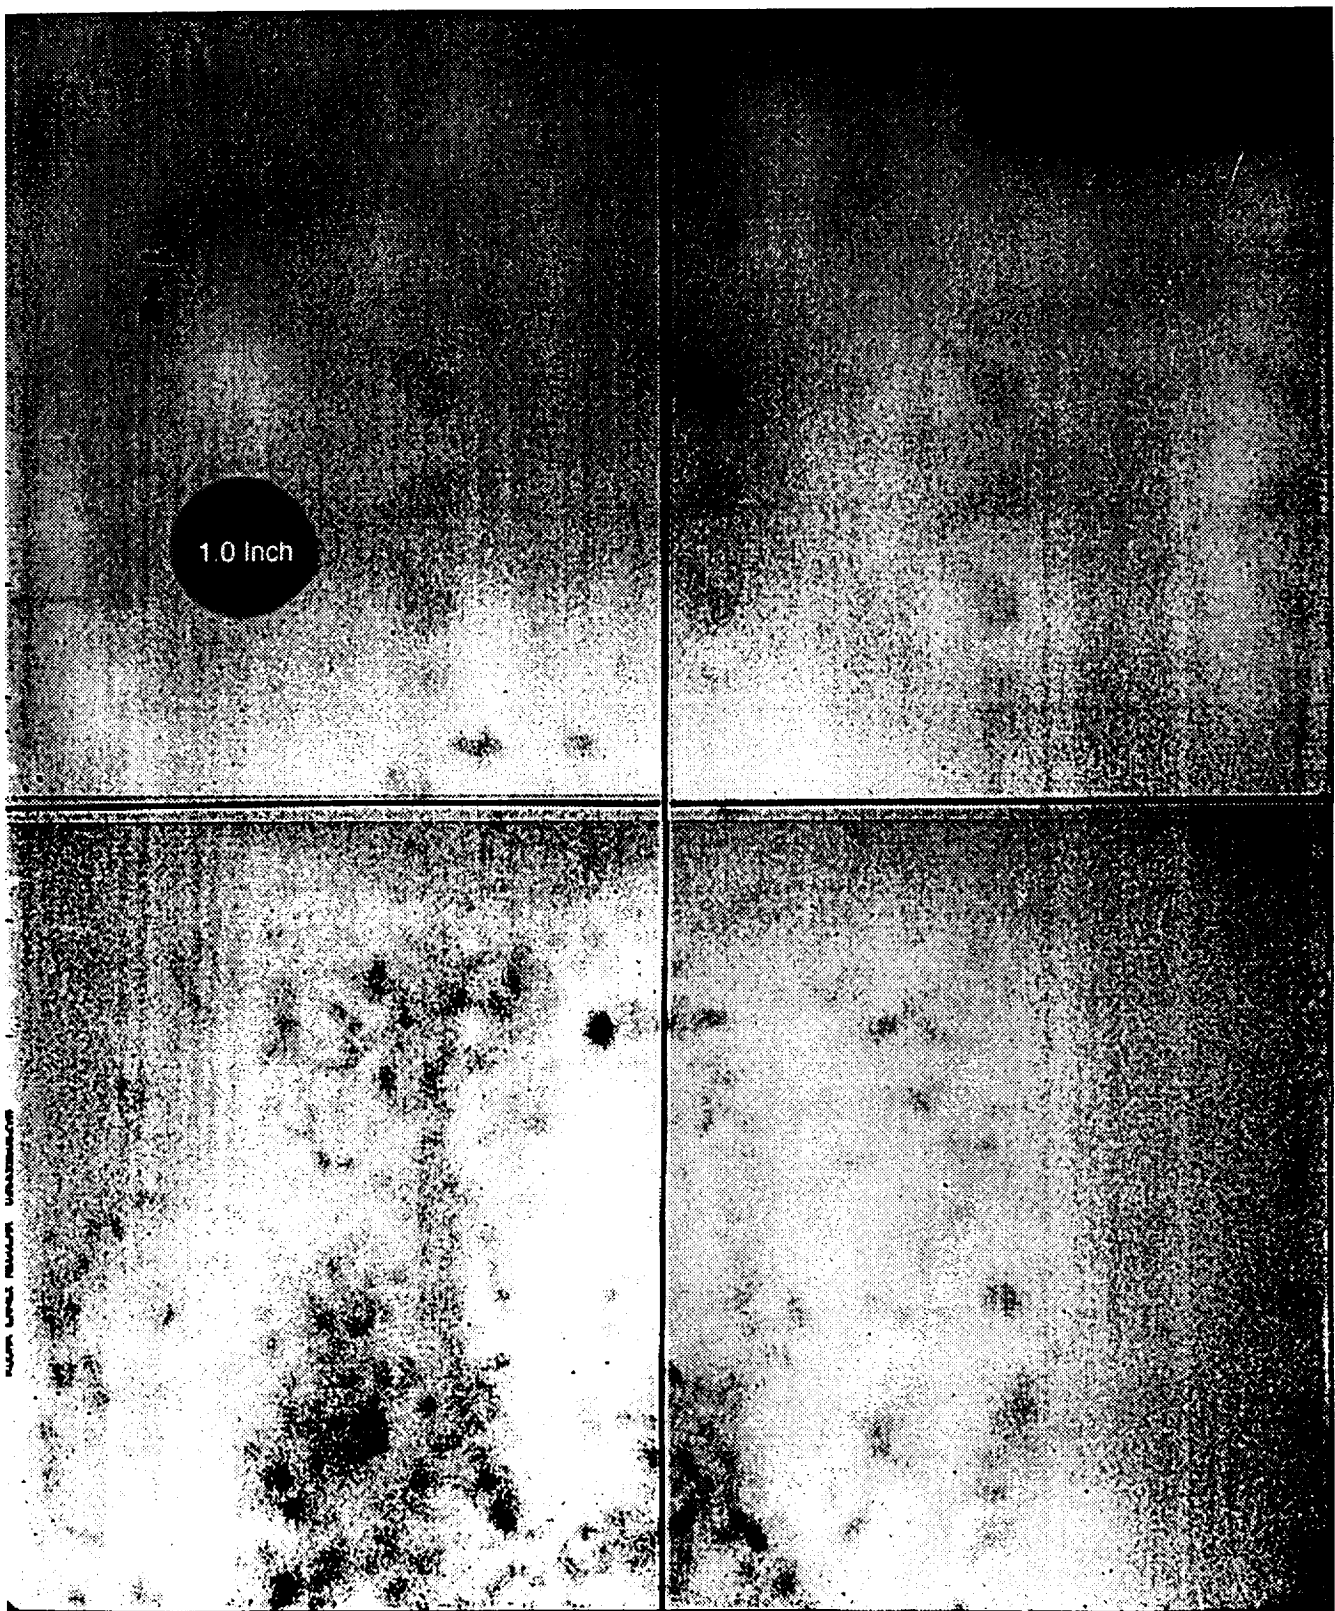
Flash X-Ray of Debris Cloud: UAH 94-61

Figure B9 X-Ray Photograph of Debris Cloud, Test # 11 X-Ray #1

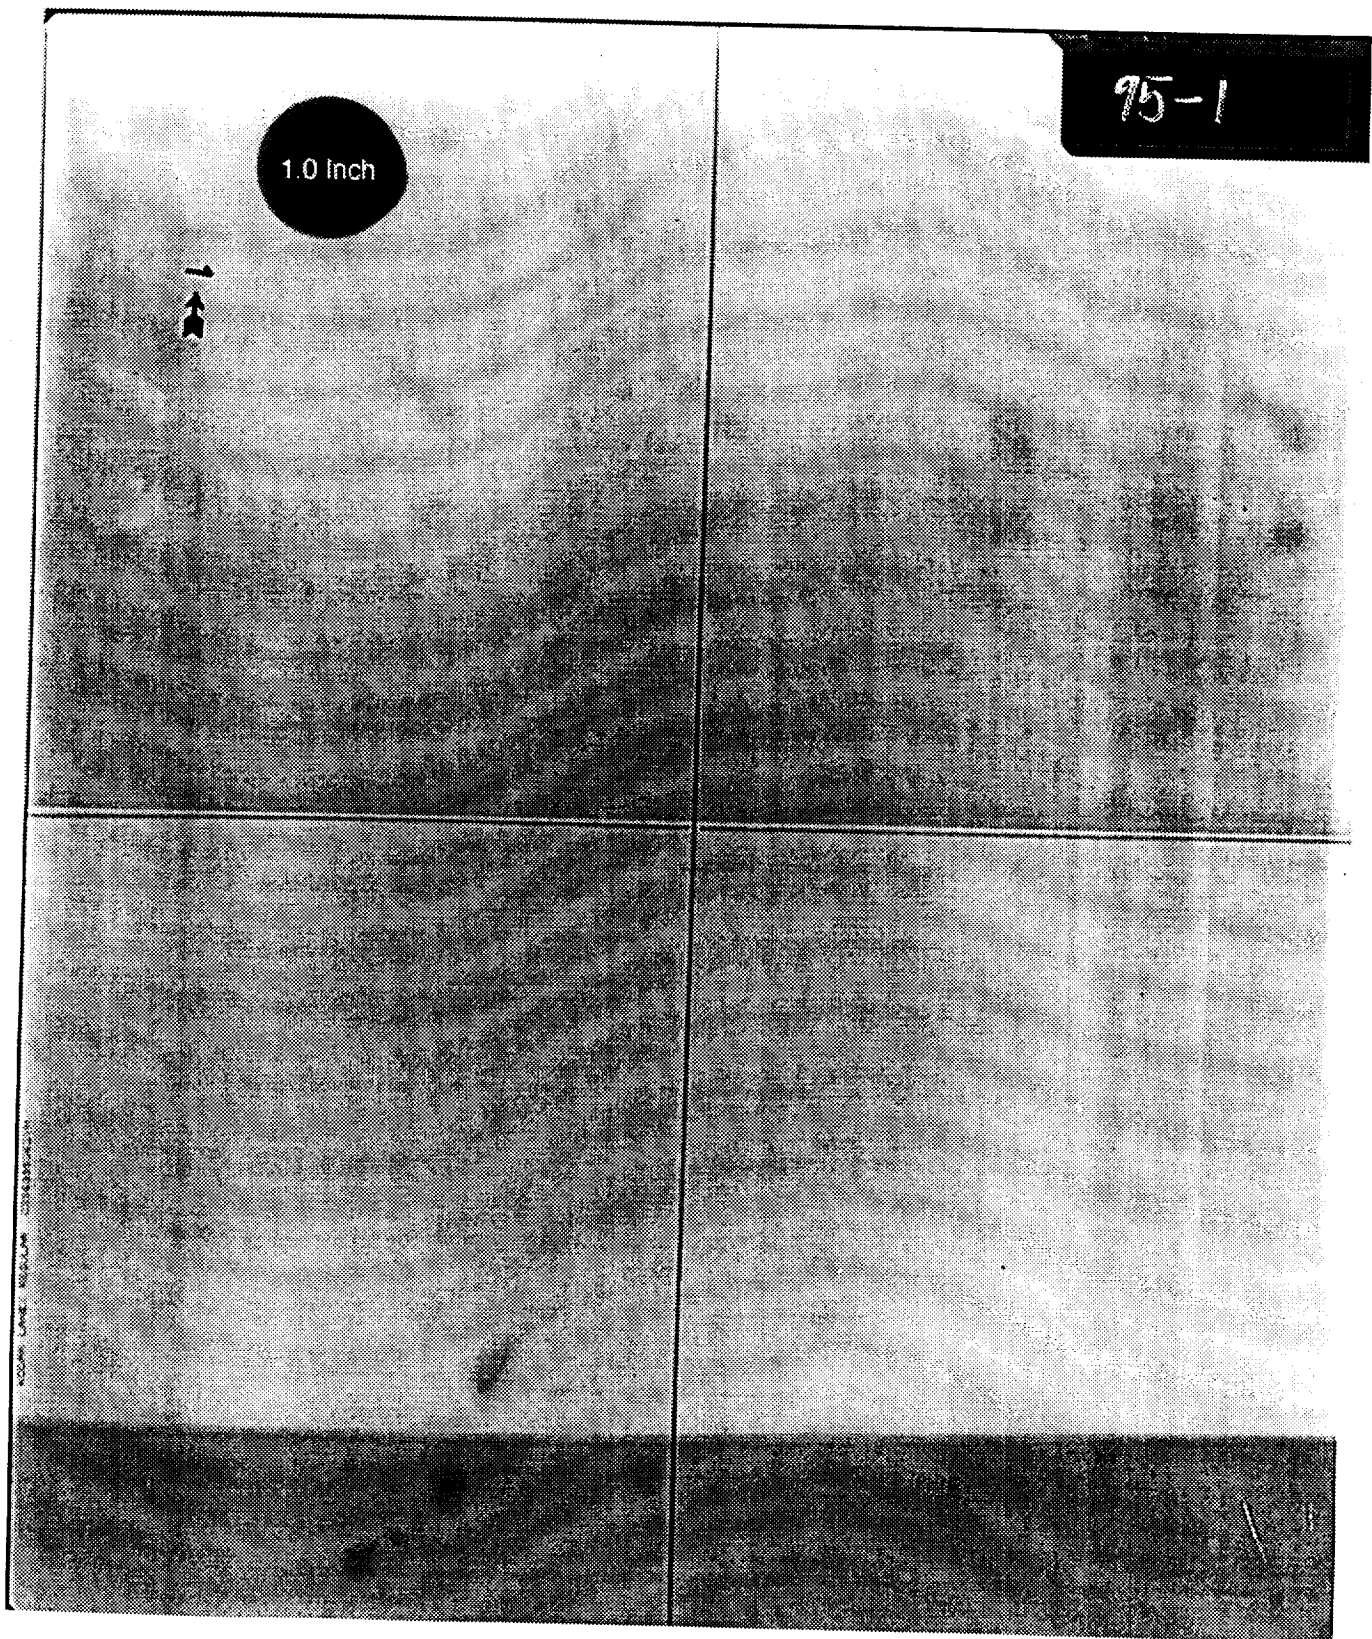
Flash X-Ray of Debris Cloud: UAH 95-01

Figure B10 X-Ray Photograph of Debris Cloud, Test # 13 X-Ray #1
